Trouble-shooting program

## 1. Rapid diagnosis chart

Danger of Accident on Semi-conductor Ignition Systems

VDT-I-227/102 B

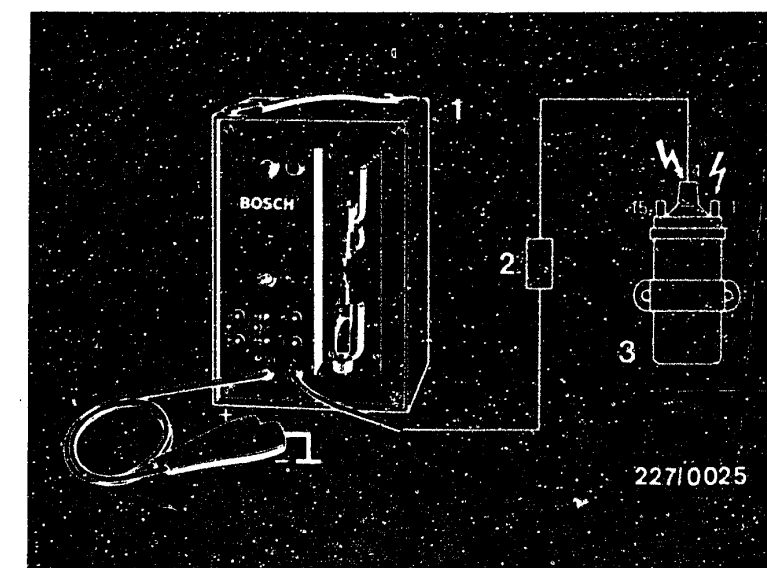
Test primary voltage or, if no oscilloscope available, check whether ignition spark across spark gap.

There must be sparks across the spark gap.

Primary voltage on oscilloscope or ignition sparks across spark gap?

If no primary voltage or no ignition spark, continue testing at C 1.

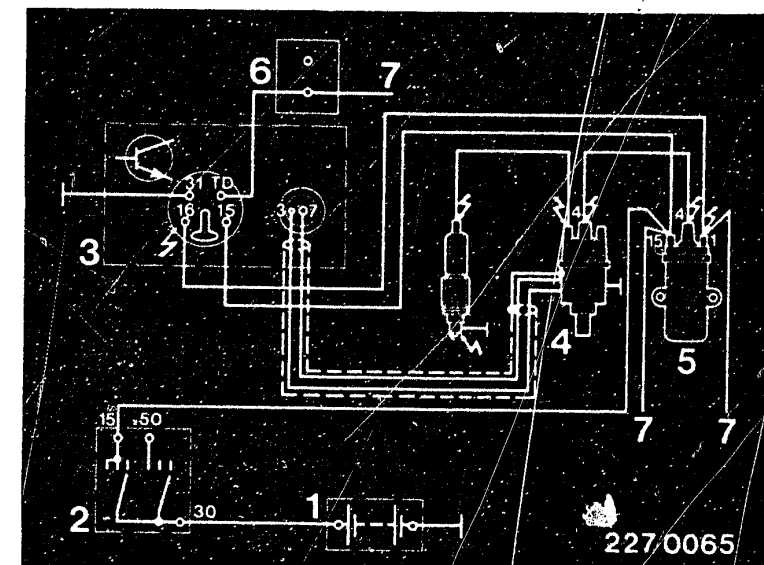
Check the peak-coil current cutoff.

Connect voltmeter to ignition coil terminals 15 and 1. The voltmeter should show a short deflection for approx. 1 s (approx. 5 V). Voltmeter must return to 0 V.

Voltage (0 V) OK?

Replace trigger box and ignition coil.

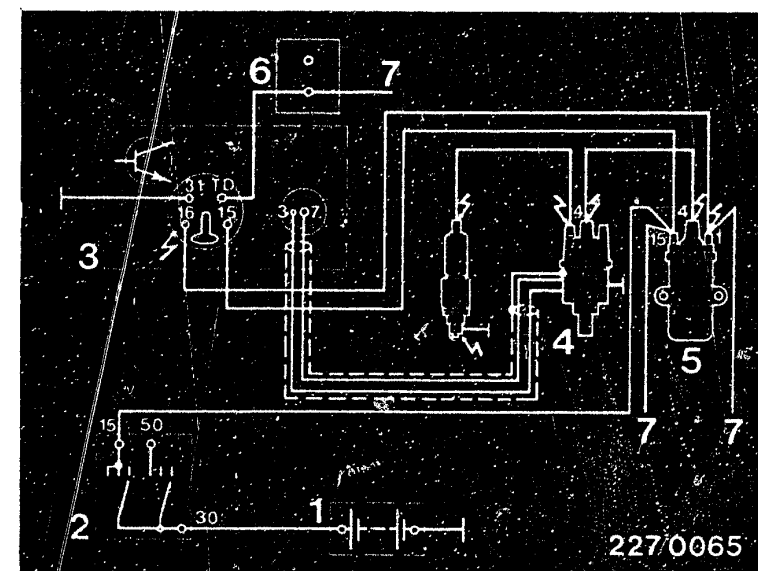
Check the primary voltage  
(if MOT series available).  
Connect the oscilloscope e.g.  
MOT 201 to ignition coil in  
accordance with the operating  
instructions.  
Run the engine at idle.  
The measured primary voltage  
must be 220...255 V. See  
Fig.  
Voltage OK?

Replace trigger box.

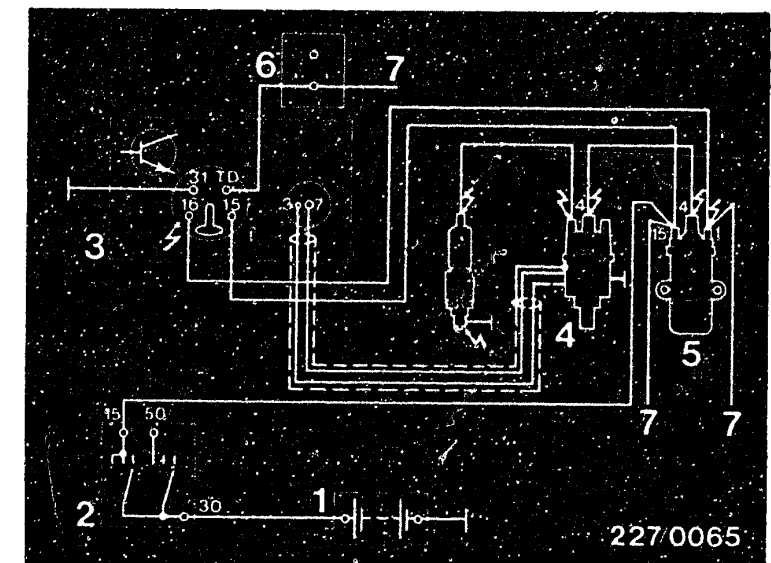
Test resistance of coil section including electric cable.  
Disconnect trigger box plug.  
Connect ohmmeter to the disconnected trigger box plug between terminal 1 and 2.  
Ohmmeter must show 485...850  $\Omega$ .  
Resistance value O.K.?

Test ground connection of coil element and electric cable.  
Connect ohmmeter to disconnected trigger box plug at terminal 1 or 2 and ground connection. Ohmmeter must show ( $\infty$ ) continuously.  
Resistance value ( $\infty$ ) O.K.?

Test pickup assembly to see if there is mechanical damage.  
Visual test: timer core must not rub against the teeth of the pickup assembly. Pickup assembly O.K.?

Replace coil section/ignition distributor or electric cable.

Replace pickup assembly/ignition distributor.

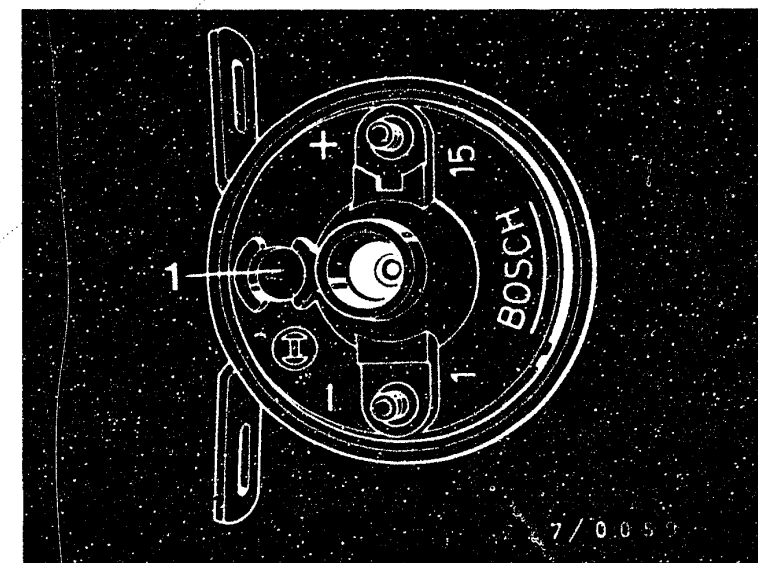
1 = Plug

Visual examination: Remove protective cap from ignition coil and check whether plug (see illustration) is in position and whether any sealing compound has escaped.

Electrical test: Ignition coil primary (term. 15 and 1)  $0,3...0,6 \Omega$  (take resistance of test lead with test prods into account).  
Ignition coil secondary (term. 1 and 4)  $6,4...10,5 k \Omega$ .

Plug in position? No sealing compound escaped?

Resistance values O.K.?

1. If plug is not in position and/or sealing compound has escaped, replace trigger box and ignition coil.

2. If resistance values are not O.K., replace ignition coil.

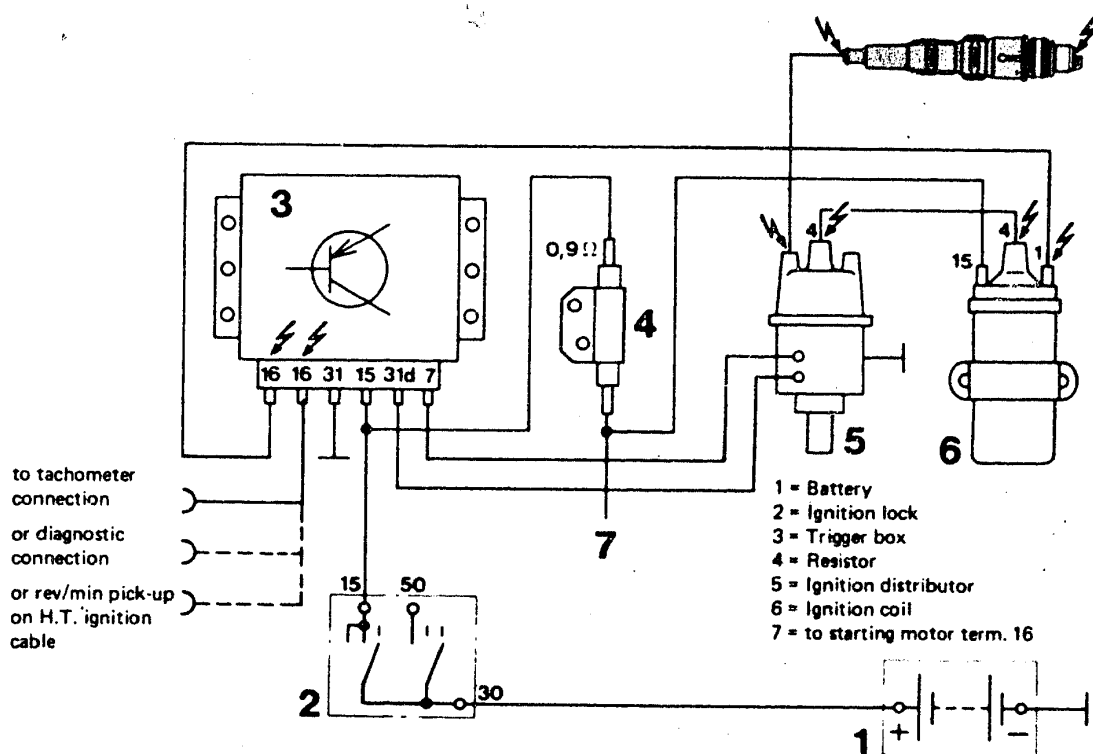
Terminal diagram

Below is a typical terminal diagram of a semi-conductor ignition system, the danger points are marked with red high-voltage arrows. We would point out that all semi-conductor ignition systems, even the older ones, are to be regarded as dangerous in the sense as defined by this bulletin.
